Subject: APPLYING CHEMICALS TO AIRCRAFT TO PREVENT SPREAD OF FOOT-AND-MOUTH DISEASE

M-7200-01-00653 10 MAR 01  
ATA 3200-00 MODEL ALL  
APPLYING CHEMICALS TO AIRCRAFT TO PREVENT SPREAD OF FOOT-AND-  
MOUTH DISEASE  
REF /A/ 767 ISAR 98-03-3211-30, DATED 20 FEB 1998, FAXED COPY,  
3 PAGES  
/B/ HONEYWELL (BENDIX) ALERT SERVICE INFORMATION LETTER  
(SIL) #710, DATED 10 MARCH 01, .PDF FILE FORMAT

### 98-03-3211-30 (767) FRACTURED MAIN LANDING GEAR AXLE

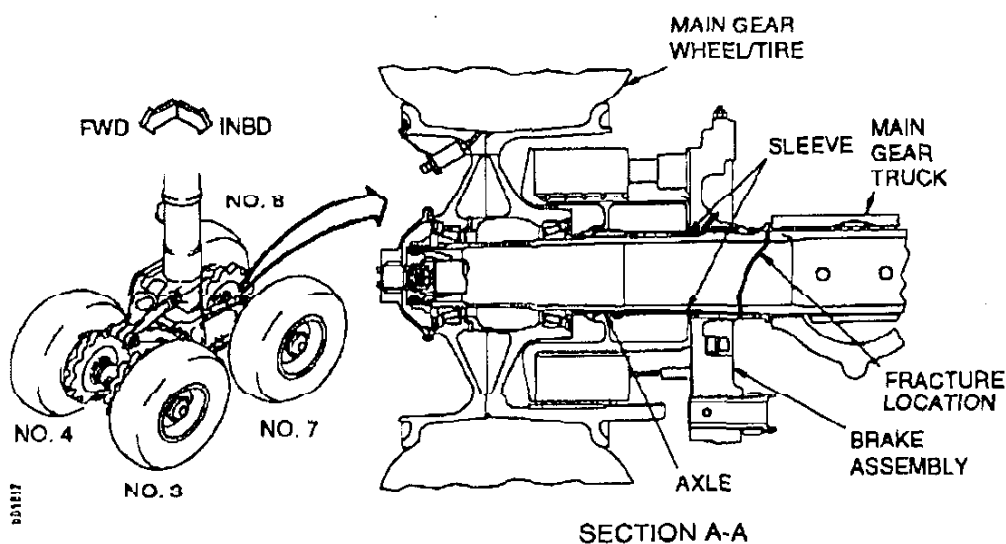
MAIN LANDING GEAR AXLE FRACTURE

1. The fracture occurred at the in-board most relief radius, about 1.3 inches from the inboard flanged end of the brake sleeve (see illustration next page). A stress corrosion cracking thumbnail was noted on the axle at the six o'clock position.
2. Corrosion and pitting were noted 270 degrees around the axle inboard relief radius and encompassed the entire width of the relief radius at the six o'clock position. Corrosion decreased to a minimum at the twelve o'clock position and was limited to the edges of the relief radius.
3. The axle material, heat treat condition, dimensions, and surface finishes were confirmed to be per drawing.
4. A large portion of the chrome plated area outboard of the relief radius was pitted and partially covered with a dark green substance identified as chromium chloride. Chromium chloride typically is a product of chlorine attack on chrome.

5. High levels of chlorine were found on the fracture surface, in the base metal pits, underneath disturbed organic finishes, and on attacked areas of chrome plating.
6. The source of the chlorine could not be determined; however, several elements were identified which form salts with chlorine, including sodium, potassium, and calcium.
